# COUNTAX™

**SERVICE BULLETIN**

**03- T7.19**

**CONCERN: Fault Finding Instructions**

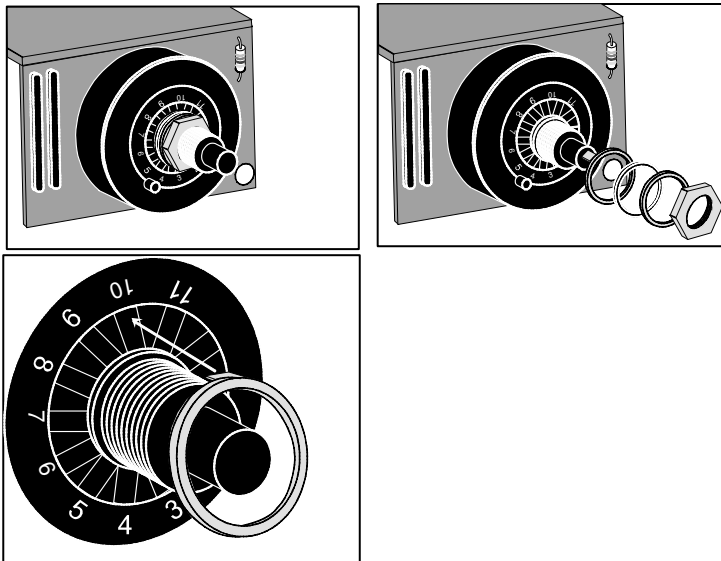
The switch has only 10 positions – this is a 12 position switch limited by a tab washer under the operating knob. Positions 11 & 12 will result in erratic deck operation.

Remove the cutter deck and the deck lift springs ( if fitted) then unbolt the actuator from the rear deck lift cradle. Then check for ease of operation of the cradle assembly. This should be easily lifted by hand. Correct or replace any damaged or sticking parts. Then refit the actuator, deck lift springs and Cutter deck.

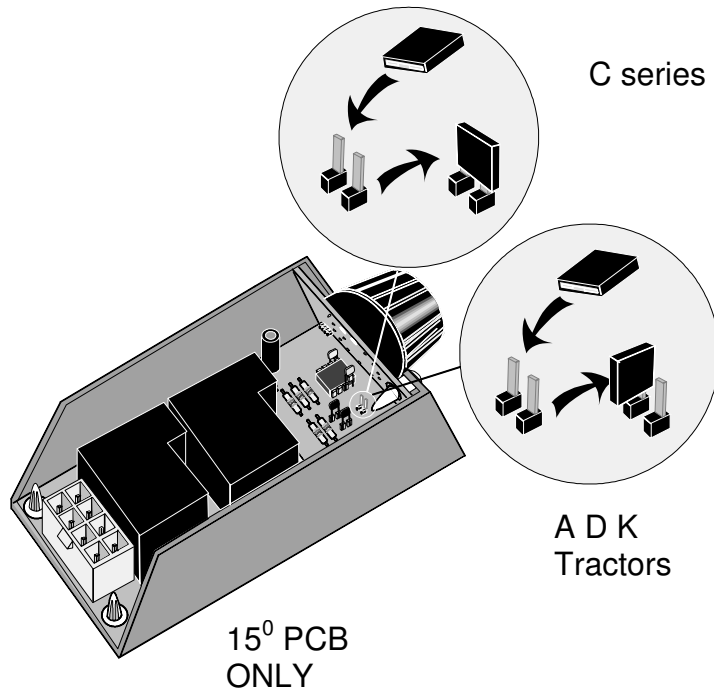
Only on C series where the link pin has not been fitted as shown in technical bulletin 03-T7.14. Once fitted the deck height may need to be altered.
